LITTLE RIVER LOWER DAM  
ME 00288

PHASE I INSPECTION REPORT  
NATIONAL DAM INSPECTION PROGRAM

NOVEMBER 1979

Identification No.: ME00288  
Name of Dam: Little River Lower Dam  
Town: Belfast  
County and State: Waldo, Maine  
Stream: Little River  
Date of Inspection: September 17, 1979

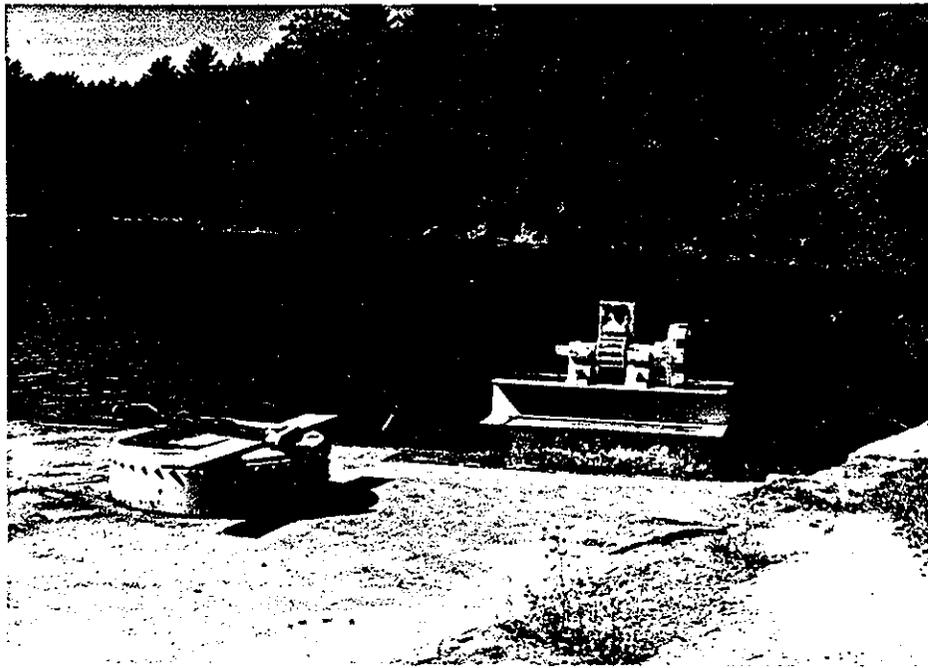
b. Mechanical and Electrical	
Air Vents	Gate operating mechanism is in poor condition-no indication of maintenance, lubrication or operation. Belfast Water District Superintendent indicated that gate hasn't been operated in 24 years.
Float Wells	
Crane Hoist	
Elevator	
Hydraulic System	None
Service Gates	Not visible-reported to be steel
Emergency Gates	None
Lightning Protection System	None
Emergency Power System	None
Wiring and Lighting System	Not applicable

September 17, 1979  
Figure 4 - Gate mechanism at the north abutment.

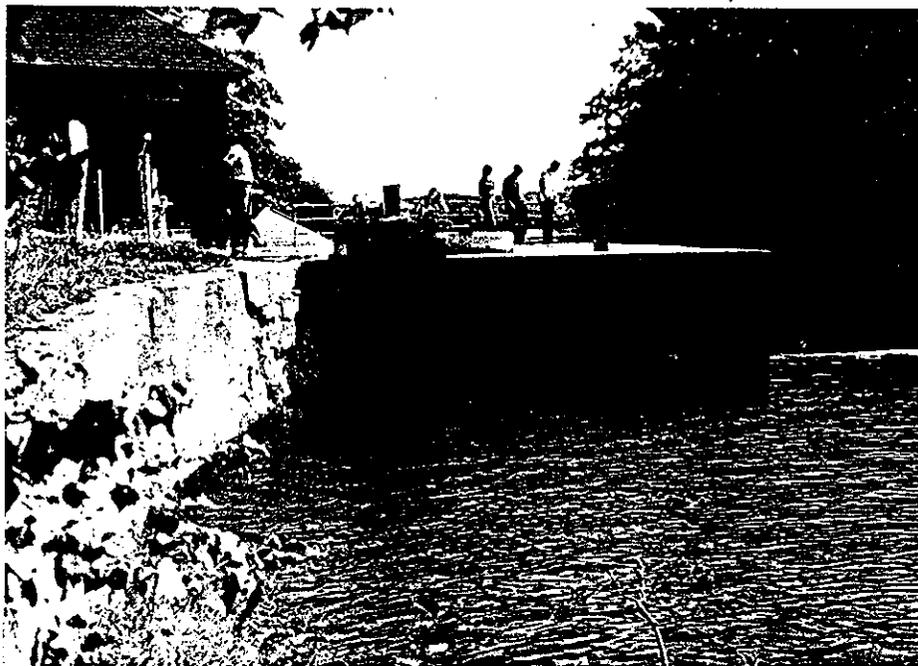
c. Appurtenant Structures. A stone masonry training wall, partially faced with concrete which is in poor condition, supports the north bank of the upstream approach channel. (See Appendix C - Figure 8.)

September 17, 1979  
Figure 8 - View of upstream side of the north abutment.

- ✓ (1) Design and implement repairs for the dry-stone-masonry walls at the downstream edge of the spillway apron, on the north bank of the upstream channel, and on the north bank of the downstream channel.
- (2) Design and implement repairs for the erosion on the upstream and downstream sides of the right concrete abutment block.
- ✓ (3) Design repairs to the low-level outlet gate, operating mechanism, and outlet pipe as required.

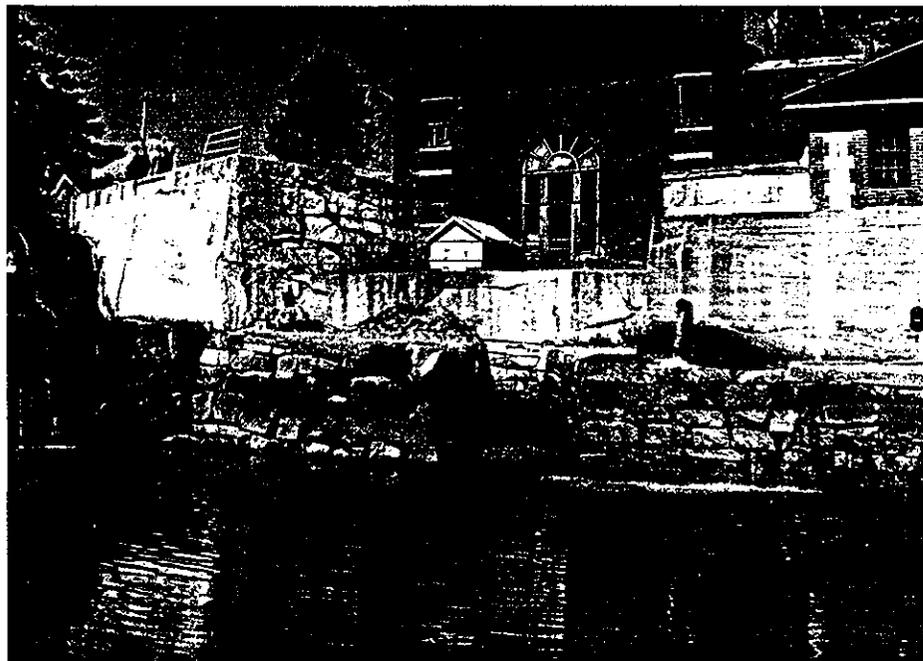
On the north bank of the downstream channel there is a concrete-faced dry-stone-masonry wall. The lower, dry-stone-masonry section of the wall is in poor condition and several blocks of rock are missing from the wall. This causes lack of support to

the approximately 8-inch thick concrete cap which is severely cracked. (See Appendix C - Figure 9.)

A 5-foot-diameter steel pipe exits at the bottom of the training wall on the north bank of the downstream channel. The outlet of the pipe is plugged with sand and gravel to about one-third of its height. (See Appendix C - Figure 9.) The gate mechanism on the north abutment is inoperable; the gate size is unknown. (See Appendix C - Figure 4.) The mechanism is in poor condition with no indication of maintenance. A pump station building and a filter house for a water supply system is located integrally with the north abutment. A concrete wall which exists on the river side of these buildings is an extension to the downstream retaining wall. (See Appendix C - Figure 10.)

September 17, 1979  
Figure 9 - Dry-stone-masonry wall at north bank of the downstream channel.

- (2) Clear the sand and gravel that partially block the discharge end of the low-level outlet pipe.
- (3) Inspect visually the dam and appurtenant structures once a month.
- (4) Engage a Registered Professional Engineer to make a comprehensive technical inspection of the dam once a year.
- (5) Establish a surveillance program for use during and immediately after heavy rainfall and also a warning program to follow in case of emergency conditions.

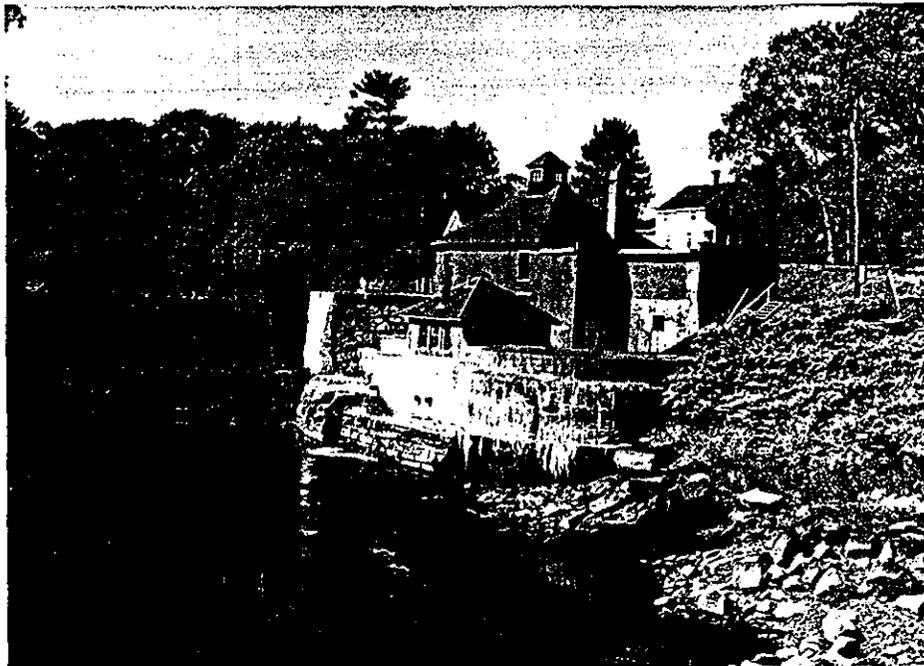
September 17, 1979  
Figure 10 - View of the north bank of the downstream  
channel from the U.S. Route 1 bridge.

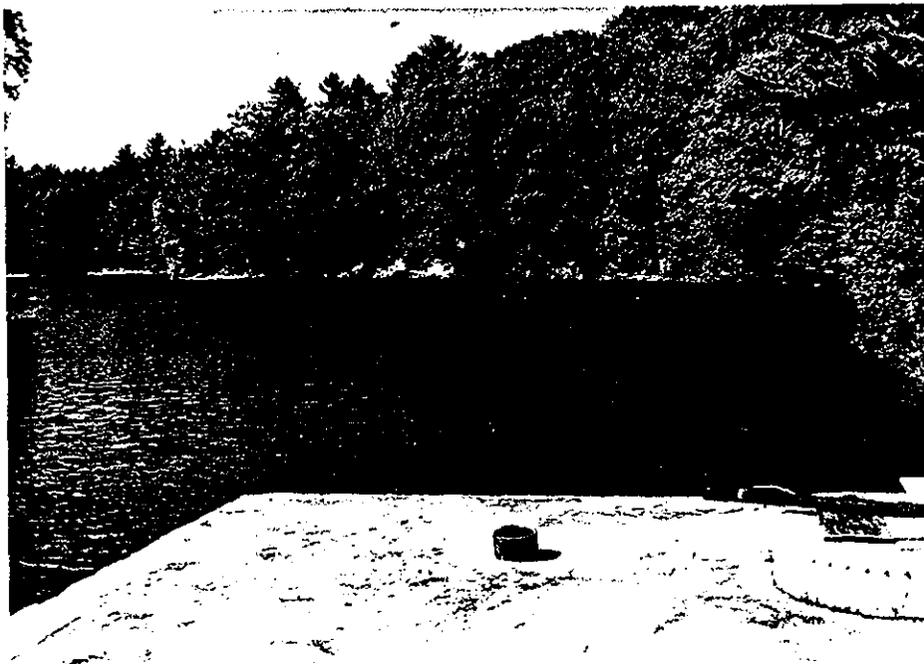
d. Reservoir Area. The watershed above the reservoir is rolling and partially wooded. (See Appendix C - Figure 11.) No structures were observed on the shore of the reservoir. No evidence of significant sedimentation in the reservoir was observed.

September 17, 1979  
Figure 11 - Looking upstream at the reservoir from  
the north abutment.
